Geological Mapping Report

Detail engineering geological study of the Kokaha Khola
Reservoir Project, Sunsari, Nepal

Central Campus of Tehnology
Tribhuvan University, Dharan, Nepal

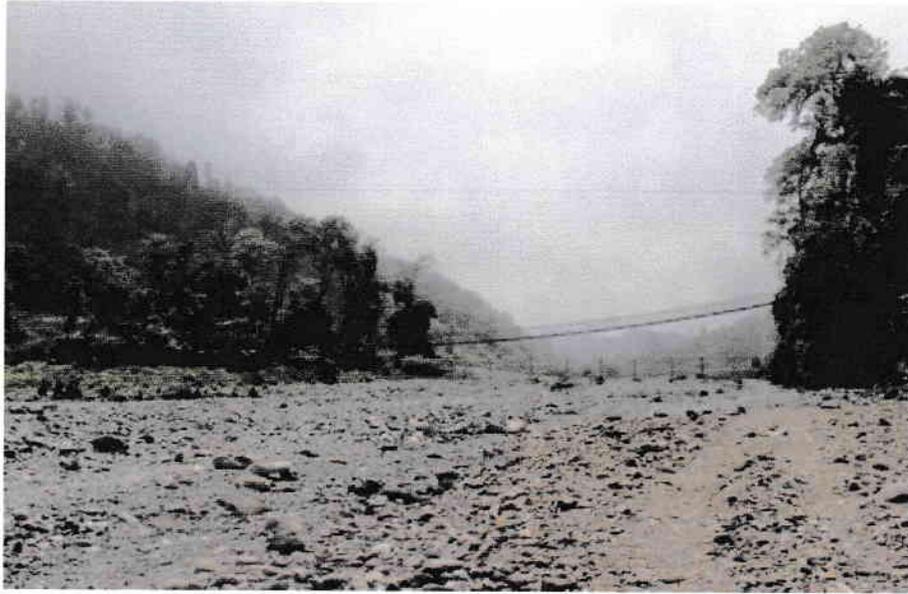
Figure 5: Upstream view of the reservoir area.

The reservoir area of the project lies on the Bishnupaduka village. Lithologically whole reservoir area lies on the Siwalik. The area is mostly covered by the alluvial flood plain of the Kokaha Khola and has gentle hillslope on the either side. The hillslope is mostly covered by the colluviums developed due to the weathering and disintegration of rock mass. On the foot of the hill slope bed rocks are exposed. The main lithology is medium to thickly bedded medium grain sandstone whose general strike is NW-SE with dip towards NE. The mass wasting phenomenon is not significant throughout the reservoir area.

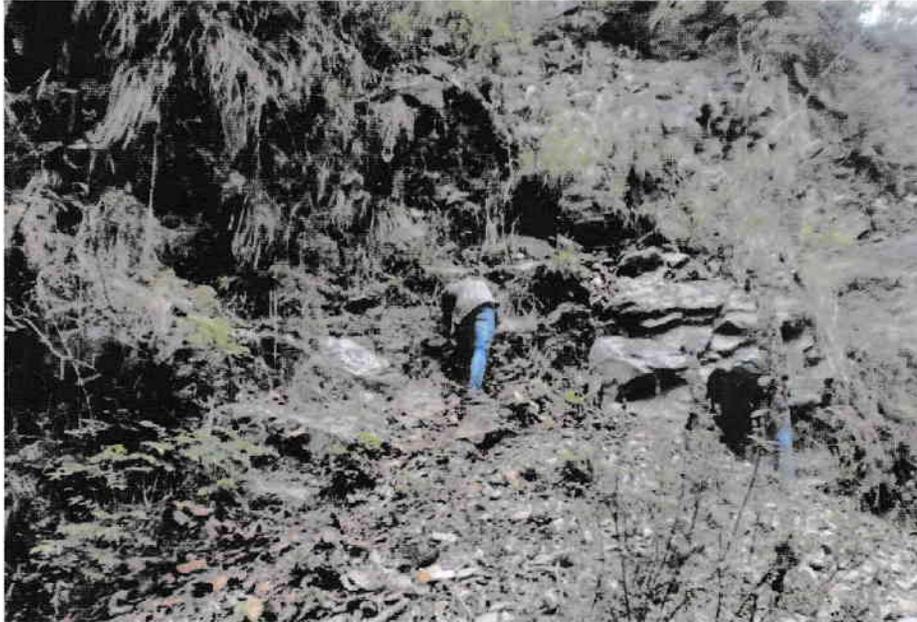
Figure 7: Rock exposure on right bank of weir axis.

The area has moderate to steep topography resulting a good rock exposure on the either side of the Kokaha Khola. The weathering and disintegration of rock mass has developed colluvial deposits on the foot of hillslope on the right bank (Figure 7). The rock exposed on the weir axis is fresh to slightly weathered thin to medium foliated dark grey slate with sporadically pencil cleavage. The attitude of foliation and joints of the beds are listed on Table 1.
